Road safety audit: a case study on NH-65

Tummala Bharat Kumar¹, Chukkapalli Jeswanth Chowdary²

^{1,2} Under graduate student, Civil Engineering Department, Velagapudi Ramakrishna Siddhartha Engineering College, Vijayawada, Andhra Pradesh, India

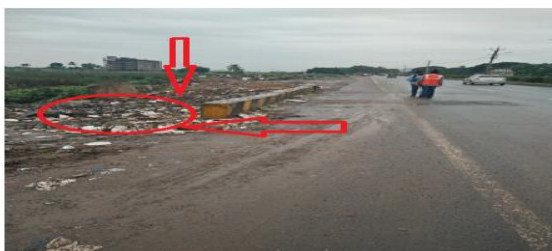
Fig.7: at chainage: 258.220km RCW.

From the figures 7,8,9,10 the waste is being dumped by the surrounding villages people at the culverts which can cause the blockade of the water at the culvert.

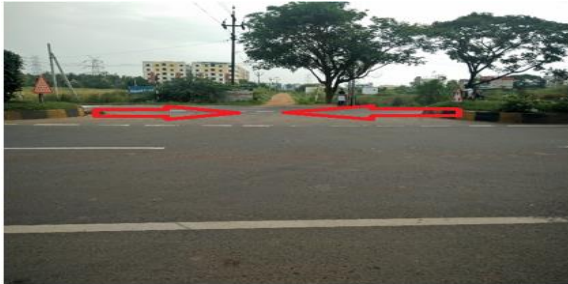
Fig.15: at chainage: 264.608km RCW.

In the figures 15,16 there is no shelter lane provided near the gap in median.

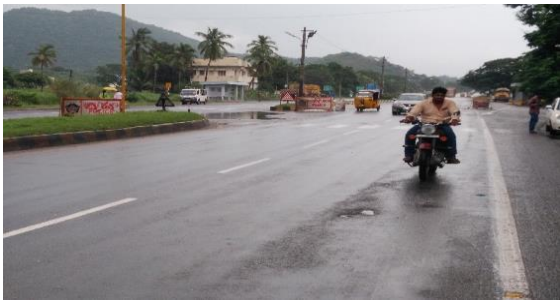
Fig.17: at chainage:256.125km RCW.

In the figure-17 there is no proper drainage facility as the rain water stagnant at gap in median.

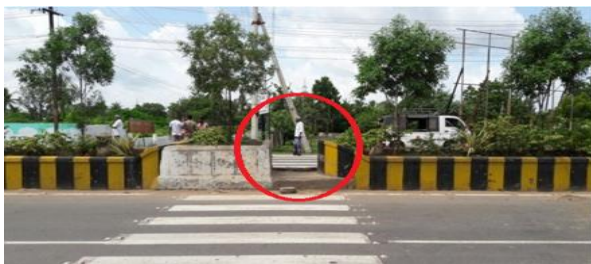
Fig.18: at chainage: 268.817km.

In the figure-18 un-authorized gap in median is provided for the pedestrians.

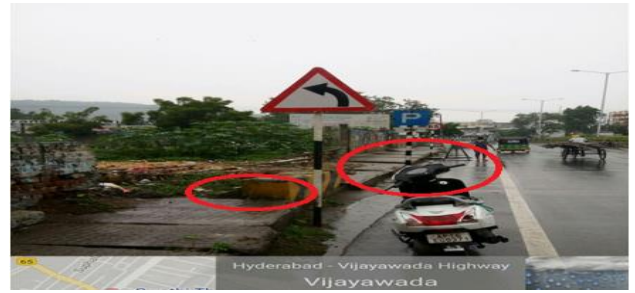
Fig.19: at chainage:269.557km. LCW

In the figure19 though there is parking sign facilities are not provided for the parking.

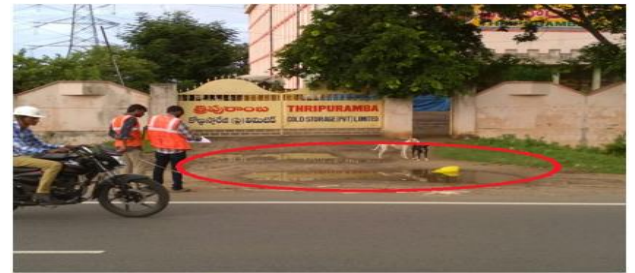
Fig.21: at chainage: 260.921km.RCW

In the figure-21,22 the earthen shoulder is damaged due to the water stagnation proper drainage has to be provided.

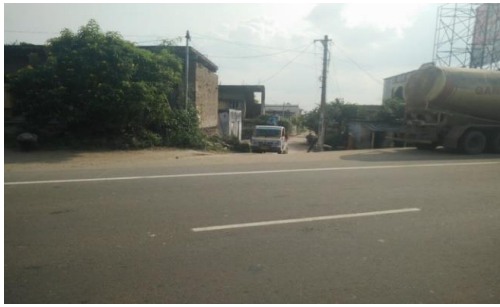
Fig.24: at chainage: 254.017km RCW.

In the figure24 there is no proper approach provided on to the NH, the approach road is very steep.

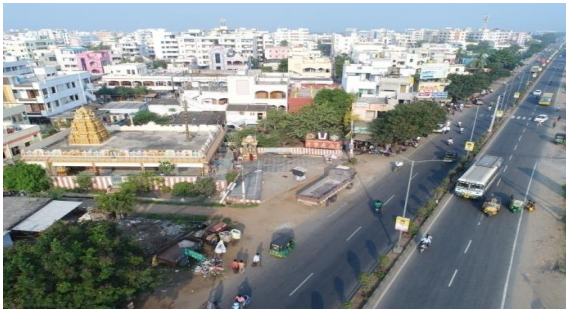
Fig.25: at chainage: 267.193km.

In the figures 25,26 the pilgrimages are on the side of the NH without any parking facilities which are causing obstruction to the flow of traffic.

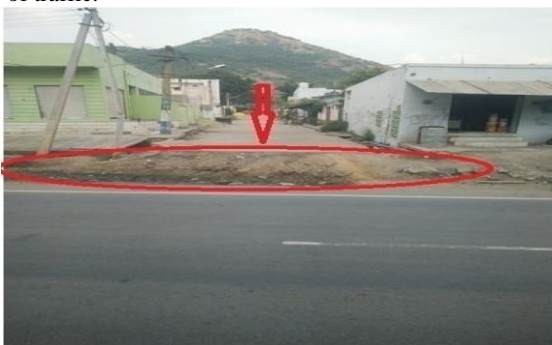
Fig.27: at chainage: 247.915km.LCW

In the figure-27 the approach to the NH is not provided it has to be laid.

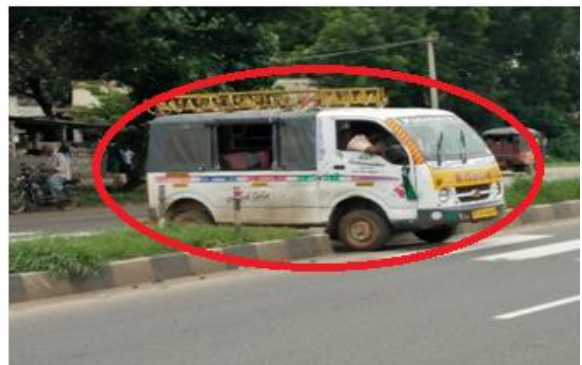
Fig.28: at chainage: 250.939km

In the figure-28 there is an un-authorized gap in median in-front of the Z. P. H school, Mulapadu village where the vehicles are using it to change the lanes which can cause accidents

All the unauthorized gap-in-median should be closed and necessary provisions like foot-over bridges to be provided for the local neighbourhood to cross the national highway on the priority basis. All undeveloped minor and major crossings should be developed with necessary lighting provisions such that the accident rate can be decreased along the surveyed areas.
