# Root Cause Detection for Excess Control Rod Vibration in Fuel Injection Pump Using Shainin Methodology

<sup>2</sup>Manufacturing Process, Bosch Ltd, Bangalore, India.

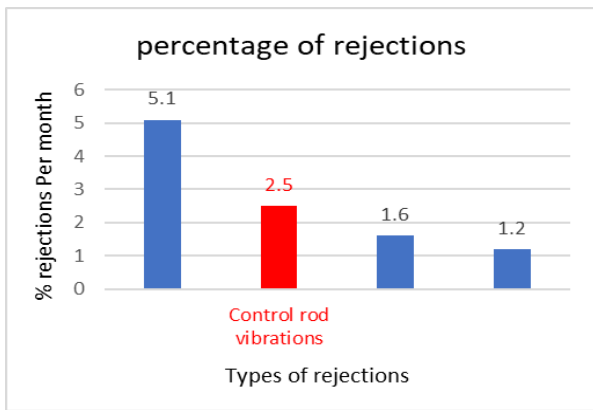
Fig. 3: Percentage of rejections per month

The rejections due to control rod vibration is 2<sup>nd</sup> highest thus resulting in production loss. The main aim of this project is to detect the root cause of the problem causing excess vibration of control rod and to provide a solution to prevent it.

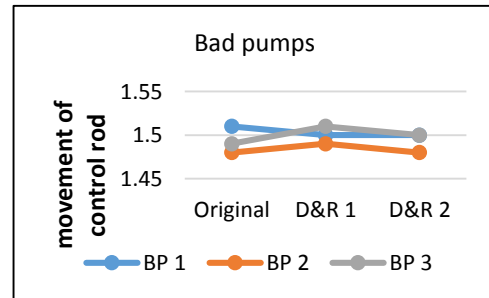
Fig. 6: Selection of bad pumps

1) Component search: In this stage, we collect bad pumps, dismantle and reassemble (D&R) twice and calibrated twice. Those pumps are selected which shows minimum variation in their control rod vibration values as shown in figure.

After this, three good pumps were collected and paired with these three bad pumps such that they have highest difference in their values.

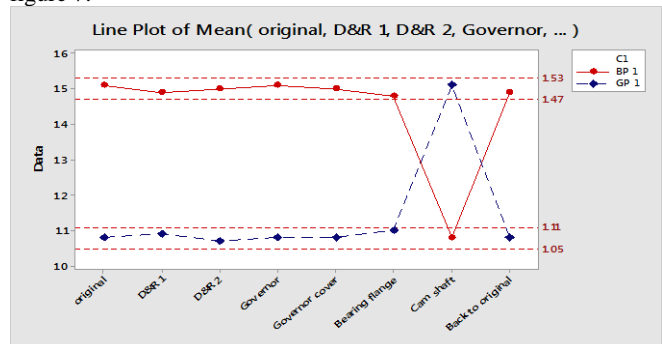
Fig. 7: Components swap results

It is clear from figure 7 that on swapping cam shaft between good and bad pump, bad pump turns to be good and good pump turns bad and same results were observed on swapping cam shaft for other two pairs which indicates the presence of Red X in cam shaft.

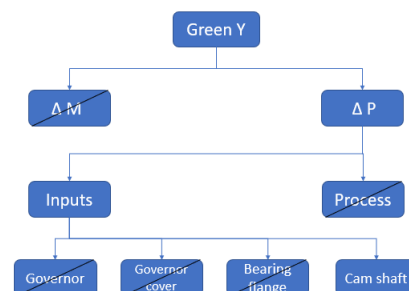
Fig. 8: Project definition tree with cam shaft as Red X component

On further analysis on cam shaft between good pump and bad pumps, it is found that the overall length of cam shaft is less than length of pump casing for all three bad pumps. The interference between cam shaft assembly and pump casing for good and bad pumps is shown in table

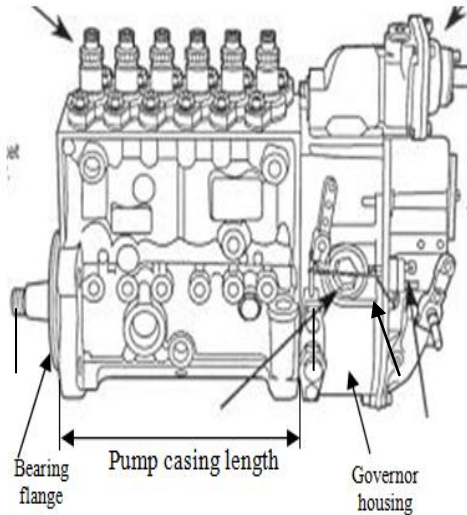
Fig. 9: Six-cylinder FIP with dimensions

It is observed that interference in bad pump is negative which means overall length of cam shaft is less than pump casing length whereas good pumps follows ideal condition. The reason for this negative interference in bad pumps is further analyzed by finding contrast in various dimensions between good and bad pumps

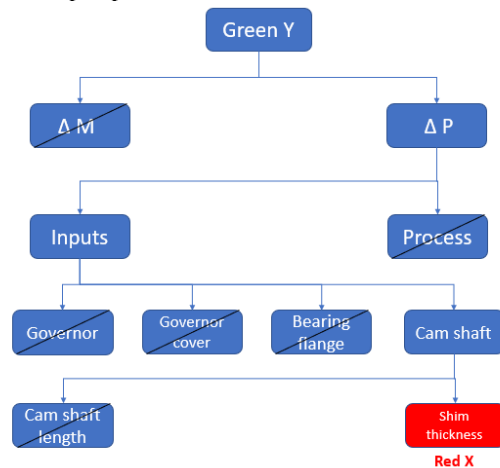
Fig. 11: Project definition tree with shim thickness as Red X factor

It is clear from above table that, left side shim thickness is less for all three bad pumps and more for good pumps. Therefore, left side shim thickness shows maximum contrast when compared between good and bad pumps.

Experimental investigation of excess control rod vibration by shainin methodology revealed that the process of shim thickness selection process is the root cause (Red X). The thickness of shim selected is not enough to cause a positive interference which causes some translational movement of cam shaft in pump case during rotation. The frequency of translational movement increases at full load which is transmitted to control rod and causes it to vibrate more than specified value. Further in this

The shim thickness of all three bad pumps were replaced with required thickness of shim and re-calibrated which is shown in table below.

study, the error in shim thickness selection process can be eliminated by automation techniques.
