Condition Assessment of Fire-Affected RC Slab Via GPR Signal Reflections Analysis and Visual Inspection Method

This study aims to assess the condition of a fire-damaged building for recommendation of repair works. The Institute of Medical Research (IMR) building, in Kuala Lumpur, Malaysia was damaged by fire in April 2011. Visual inspection (VI) is the normal assessment method, but for more accurate results, Ground Penetrating Radar (GPR) signal reflections analysis is employed. The defects analyzed are cracks and delamination of the affected area which was the reinforced concrete (RC) slab at level 3, location where the fire had started. The results obtained using GPR and visual inspection were compared. The area where cracks were detected visually was confirmed by results from the GPR signal reflections analysis but visually, only 28% of the slab area showed delamination defect. When checked with GPR, the area of delamination was actually 56% of the slab area. Cracks and delamination damage mapping was prepared in order to help facilitate repair works. This result shows that Ground Penetrating Radar (GPR) signal reflections analysis had detected delamination in RC slab where nor

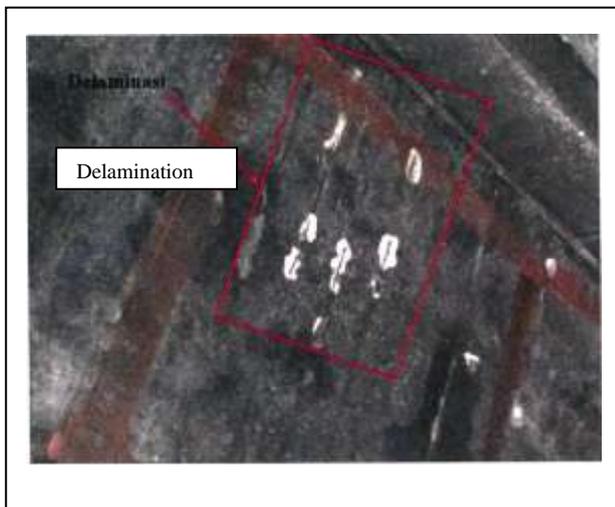
Based on the visual inspection evaluation on both slabs, the concrete delamination was detected at location "A" and cracks were identified in RC slab at location "B". Figure 4 shows the existence of delamination on slab at location "A" and cracks at location "B" are depicted in Figure 5.

Fig. 4: Delamination at soffit of slab surface

The deterioration of both slabs was found on the slab soffit and they were identified as in a critical deterioration state (Rate 4 from Table 1); which needs more detail inspection method to determine the necessary repairing or rehabilitation works to restore the slabs to its original state (Table 2). Rate 4 suggested detail inspection method needs to be done, thus the employment of the GPR signal reflections analysis on the slabs.

Deterioration Type	Surface	Visual inspection grading scale	Severity interpretation
Delamination (Location A)	Soffit of slab	4	Critical
Cracks (Location B)	Soffit of slab	4	Critical

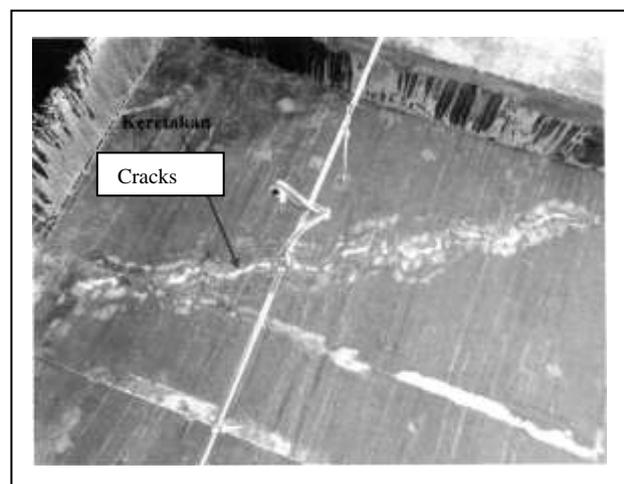
Fig. 5: Cracks at soffit of slab surface

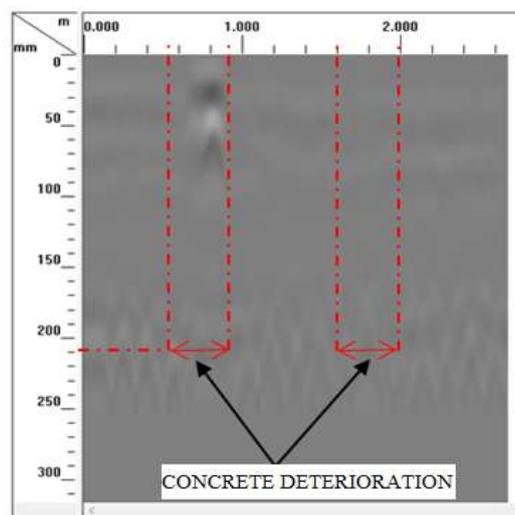
Figure 6 shows the image taken at grid number 4 at location “A” that has been analysed using RADAN 7 software. It can be seen that hyperbolic reflections wave had appeared at depth of 210 mm, which is the depth of the rebar. The hyperbolic reflections are identified as the rebar. Upon observation of the hyperbolic reflections, weak hyperbolic reflections were detected at distance 550 mm to 950 mm and from 1600 mm to 2000 mm from the initial scanning position, showing there exist different medium (void or rust) other than steel. This hypothesized that the delamination at location “A” is located at depth 210 mm from the soffit slab surface with the length of 400 mm.

Fig. 6: Subsurface image at location “A”

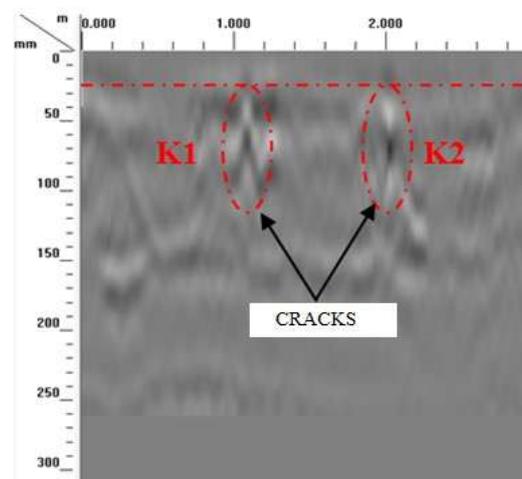
At location “B” of the slab, cracks images were displayed by a strong hyperbolic feature as shown in Figure 7. This image was taken at grid number 9 at location “B” using GPR and analysed by RADAN 7 software. It can be hypothesized that cracks were initiated from distance of 1100 mm and 2000 mm at depth of 25 mm from the slab soffit surface. The cracks defect was detected based on the travel time difference observed at location marked by the oval (K1 and K2) in Figure 7. At location K1 and K2, the time taken for the wave to travel two ways is shorter than at any other locations, showing different medium other than concrete existed (air - crack).

Fig. 7: Subsurface image at location “B”

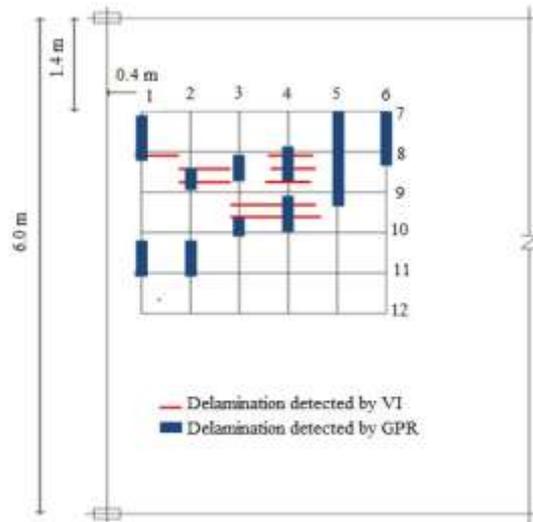
Almost 90 % of the detected delamination work done by the visual inspection method were also able to be identified by the GPR inspection work (Figure 8), but more areas where VI does not show delamination were detected by GPR. It can be seen that the delamination damage that can be detected by GPR inspection work is 56 % of the slab area, while visual inspection method only captured the similar damage type at less locations, only 28 % of the slab. This shows that GPR can detect delaminations of rebar under concrete cover, where our eyes fail to see them.

Fig. 8: Comparison of delamination results

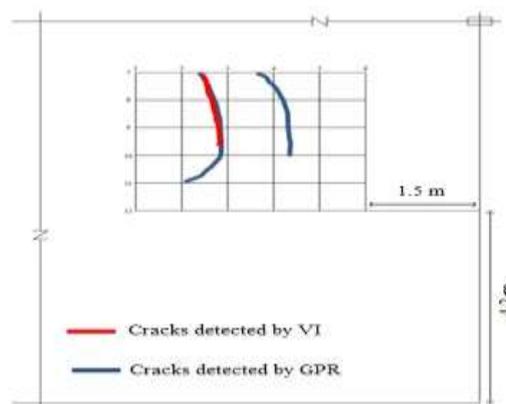
During VI, one crack with 1.5-meter length was found on the slab soffit surface (Figure 5). However, the 1.5-meter length actually extends up to 2.4 meter as shown in Figure 9, detected by GPR measurement and another a 1.8-meter length crack actually was also detected in the reinforced concrete slab using GPR, which is not visible to the naked eyes. This also concludes that GPR can detect cracks inside concrete, which could not be detected by VI.

Fig. 9: Comparison of crack detection results

At location "B", two cracks damages have been quantified by GPR with the length of 2.4m and 1.8 m when only one crack with the length of 1.5 m was detected by the visual inspection method. It is worth to note that the first position of the crack detected by GPR is same as the visual inspection method with dissimilar crack length, but the extent of the internal cracks could only be detected through GPR.
