Design Features of Thermomodernization of Combined Roofs

Abstract

Characteristic damages Groups of public buildings combined roofs are distinguished. The recommendations on the thermal modernization of combined roof structures are given. The heat-shielding properties of the combined roofs structures, their moisture state are studied. Recommendations for additional insulation of these structures are given, which allow bringing the heat-protective properties of the considered constructions to construction regulations.

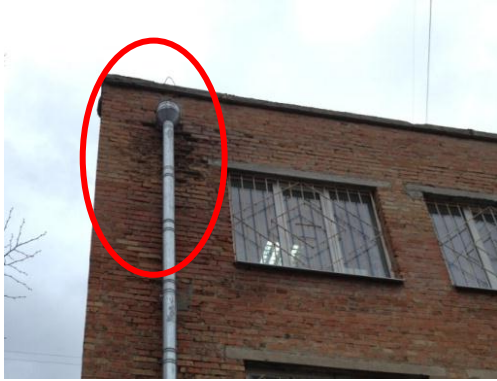
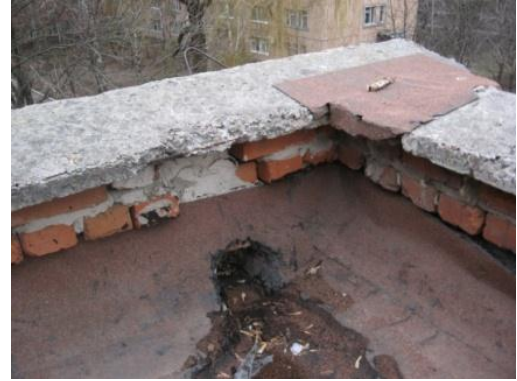
- washout of mortar and general brickwork destruction of walls in places of external drainage (fig.1, a, b)

Fig. 1. The main typical defects of combined roofs: a, b) brickwork destruction of walls in places of external drainage; c) destruction of the parapet brickwork; d) destruction of parapet plates; e) separation of the coating carpet; f) leakage of the carpet covering in places of metal racks installation, outlets of sewer risers, etc.; g) destruction of bitumen coating on roof superstructures; h) violation of the drainage gradient and the formation of drainage areas.

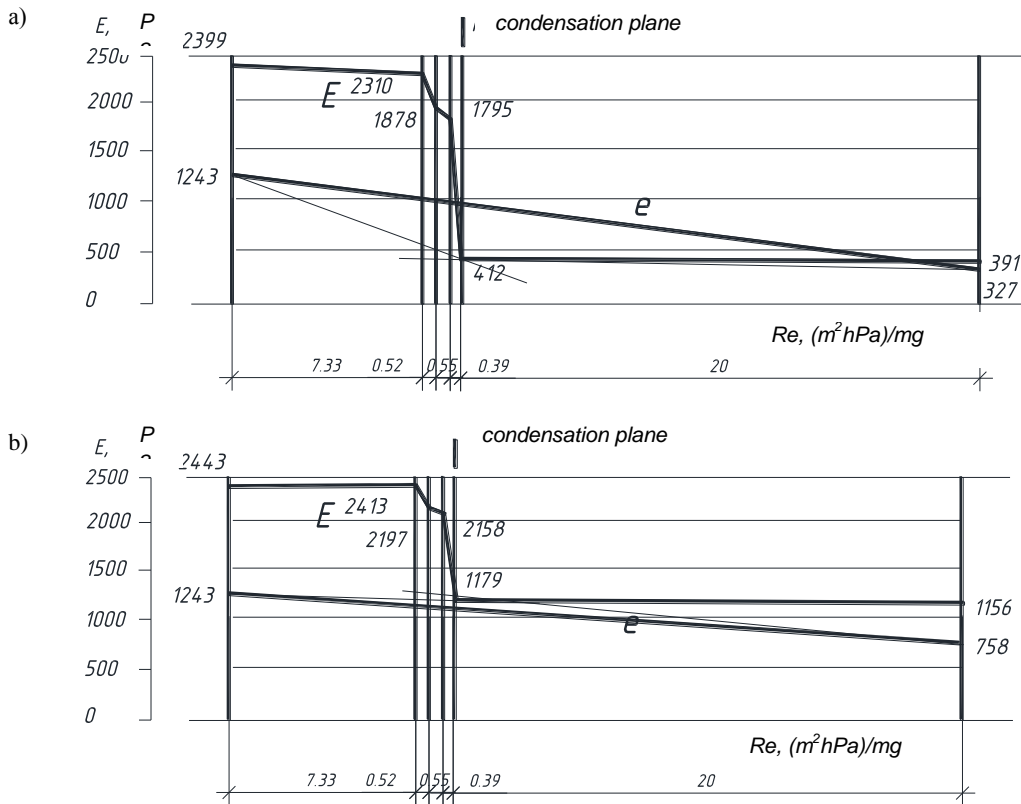
Fig. 4. Graphs of the distribution along the cross-section of the water vapour pressure barriers e and the elasticity of saturated water vapor E and the elasticity of saturated water vapor E : a) the wet accumulation period (January) b) the moisture yield period (April).

The moisture regime estimation of the combined coatings after thermal modernization was carried out for climatic conditions in Poltava. On fig. 4. The distribution graphs of partial pressures in the thickness of the moisture accumulation period enclosing structure (fig. 4, a) and moisture yield (fig. 4, b) are given.

According to the calculations, it has been established that in this variation of the combined coating on the basis of a hollow reinforced concrete slab with an effective insulation (basalt wool), the

condensation process of water vapour takes place during four months: December, January, February, March. During other months of the year there is a process of moisture evaporation condensed. It was estimated the increasing of the moisture content in the material in the thickness of the layer of the structure where moisture can condense during the cold period of the year, which is 0.8% and according to DBN B.2.6-31: 2016 [4], the increase in the moisture content of the mineral wool layer during the cold period of the year is admissible. It is recommended to install a vapor barrier layer below the mineral wool insulation layer in order to prevent accumulation of moisture for the combined buildings coatings.
