Empirical investigation of indoor environmental quality (IEQ) in a hospital building in Merida Yucatan, Mexico

Abstract

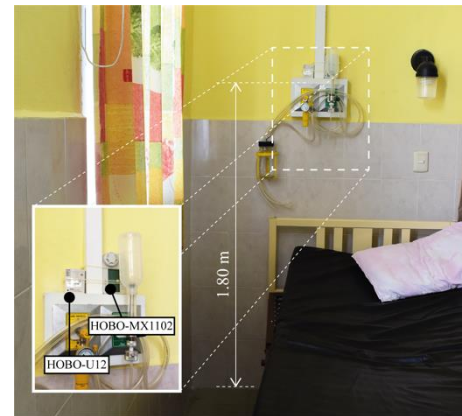
Fig. 1: Measurement

instruments for Winter in Room 01.

The data was collected continually every minute, while the room was occupied. The measuring instrument is conducted at the bed patient's location at 1.80 m above level floor as shown in Figure 1, 2, 3 and 4. The instruments used for the measurement are described in Table 2.

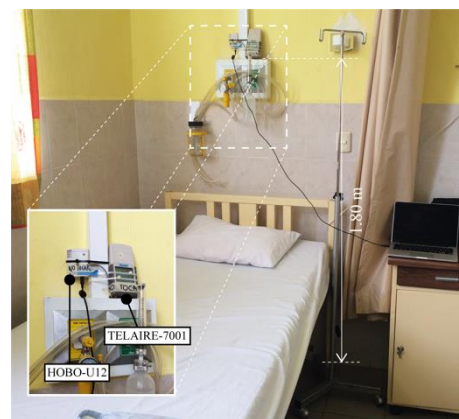
Fig. 2: Measurement instruments for Summer in Room 01.

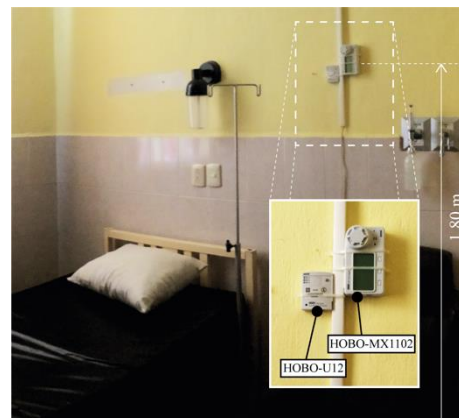
Fig. 3: Measurement instruments for Winter in Room 03.

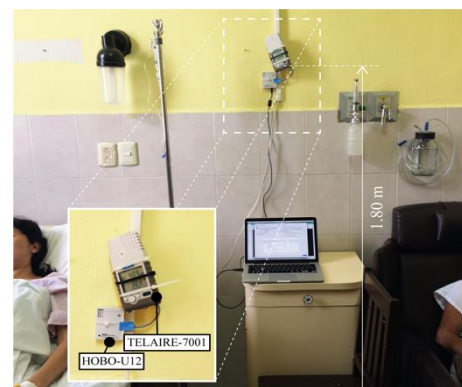
Fig. 4: Measurement instruments for Summer in Room 03.

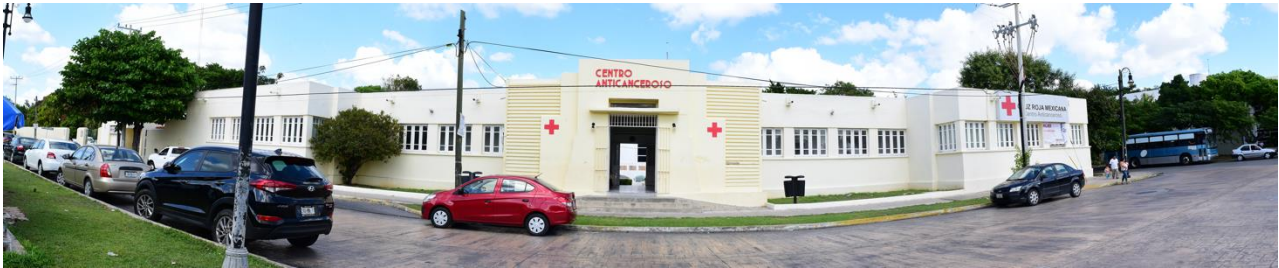
Fig. 5: Main facade of the building.

The case study has a capacity of five rooms designated for ambulatory and post operative hospitalization, with services of treatment for cancer like radiation, chemotherapy and operating room. The building has a historic importance, because it was built from 1943 to 1945 and was inaugurated in 1946, one of its kind in the region at the time. This is found in Figure 5 and Figure 6. The formal characteristics of the building can be appreciated.

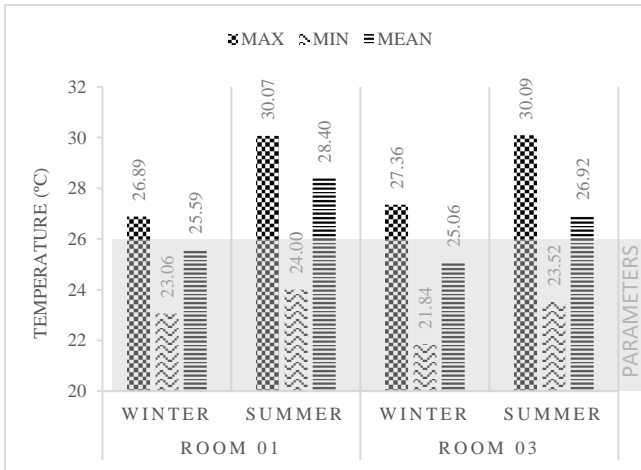
Fig. 8: Periodic results for Room 01 and Room 03 in both seasons. Indoor temperature. MIN = minimum, MAX = maximum, °C = Centigrade

Considered a primary factor for comfort and health of the patient. The thermal comfort is measured by indoor temperature and relative humidity. Based on ISO 7730:2005 the parameters considered are $22^{\circ}\text{C} \pm 2^{\circ}\text{C}$ for winter and $24.5^{\circ}\text{C} \pm 1.5^{\circ}\text{C}$ for summer. The results obtained in the rooms are represented in the Figure 8. The recorded mean temperature in Room 01 (25.59°C) and Room 03 (25.06°C) in winter is between parameters, but it does not apply in the mean temperature in the summer as it is above 2.4°C in Room 01 and 0.92°C in Room 03 from the maximum permitted. Inclusive of the maximum temperature in both rooms which shows more than 4°C from the limit permitted for the comfort of the patient. The differences between them show minimum changes in the temperature.

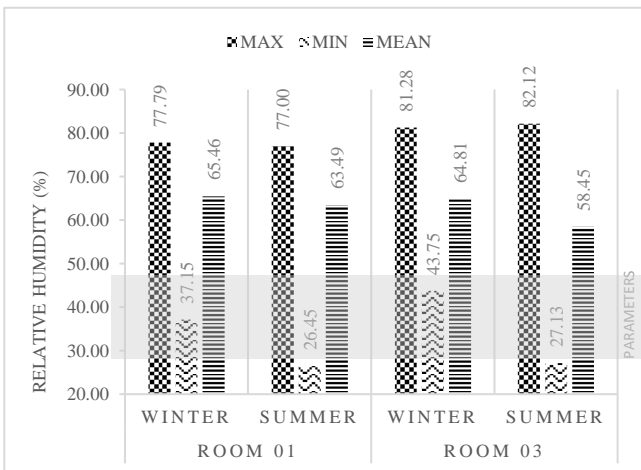
Fig. 9: Periodic results for Room 01 and Room 03 in both seasons. Indoor relative humidity. MIN = minimum, MAX = maximum

In the case of the humidity control, it is essential for achieving a level of comfort that guarantees working efficiently and quality of life in hospitals. Analysis of building structures also takes into account occupant comfort: this aspect is even more important in hospitals, where there are patients, visitors and healthcare workers at risk of infection due to germs, bacteria and viruses. The right humidity reduces airborne proliferation and propagation of pathogens, making the environment safer. The WELL Building Standard (2017) requires maintaining relative humidity between 30% to 50% at all times. The results shown in Figure 9, the maximum registered in Room 01 is 77.79% which is above the parameter, in Room 03 the difference is bigger 32.12%. We need to consider the location, the type of building and materials because this can cause, big differences to keep a healthy environment thereby causing more health problems on the patients inside the rooms.

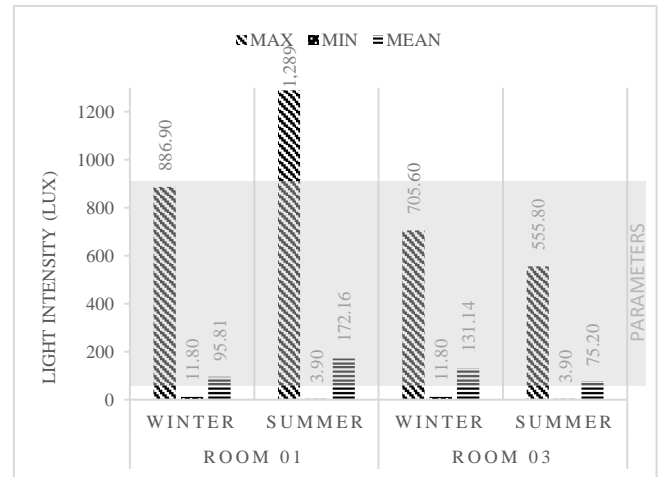
Fig. 10: Results MIN = minimum, MAX = maximum and mean of light intensity levels.

The variations in light intensity levels are shown in Figure 10. The highest recorded was 1289 lux on the summer season in the room 01, having a big difference between room 03 which had at maximum 705.60 lux in winter season. In the case of room 03 it never reaches the optimal conditions of lighting, during the continuous measurement in both seasons.

Having similar architectural features, we can see the big difference between a room with one (room 03) and two (room 01) windows. The difference reaches 583.40 lux in its maximum measures recorded.

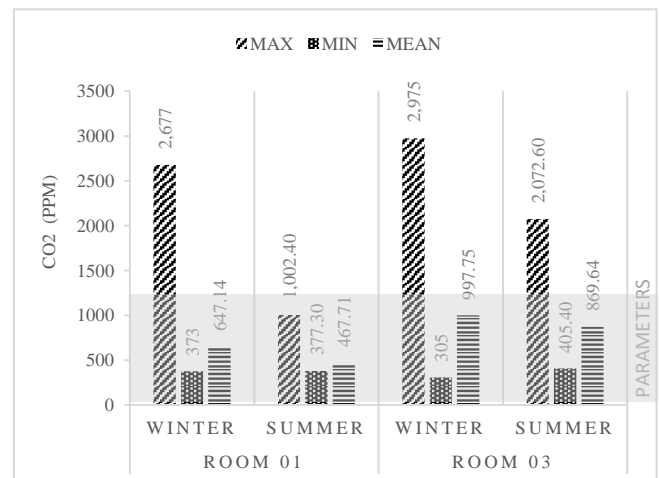
Fig. 11: Results minimum, maximum and mean of CO₂ = Carbon Dioxide levels. MIN = minimum, MAX = maximum

Levels of CO₂ are not considered in different standards as pollutants, but being present in excessive levels in some spaces, is considered for the comfort of the user's space, ASHRAE 62.1-2016 [11] tells us that indoor CO₂ concentrations of 1000 to 1200 ppm (parts-per-million, 10⁻⁶) in spaces for sedentary activities, is an indicator that a substantial majority of visitors entering the space will be satisfied. The Figure 11 shows the results of the measurement, in this case the higher number was obtained in Room 03 with 2,975 ppm, which showed more than double the amount considered as optimal comfort. The lack of cross ventilation could have been the result of the higher level of CO₂ concentration recorded.

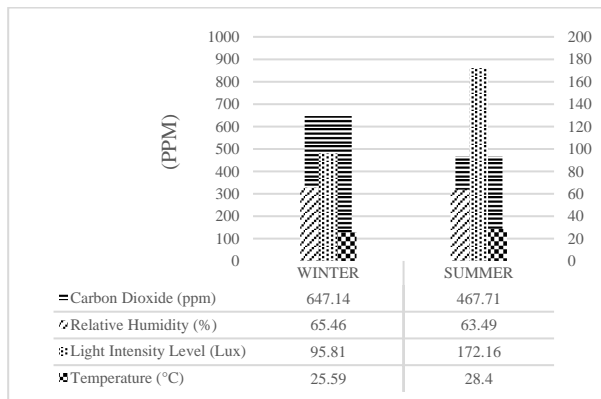
Fig. 12: Mean values of measured indoor variables in Room 01. PPM=parts-per-million, 10⁻⁶, °C = Centigrade

In Figure 12 and 13 the differences between the mean values measured in each room can be appreciated. The room 03 presents the higher values in CO₂ levels. The data is integrated as an abstract, to compare the small differences in the other variables.

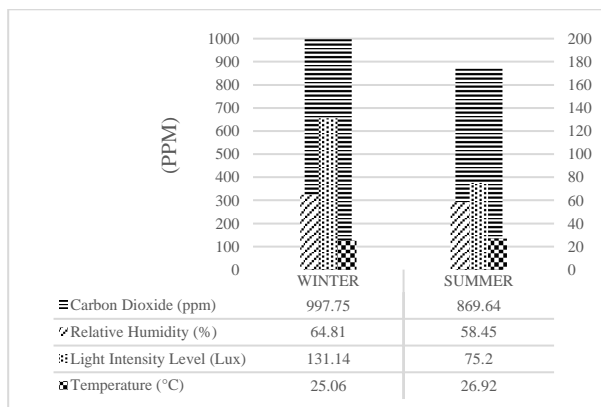
Fig. 13: Mean values of measured indoor variables in Room 03. PPM=parts-per-million, 10⁻⁶, °C = Centigrade
