Rehabilitation of Beam Column joint using Steel Fibrous Concrete

Abstract

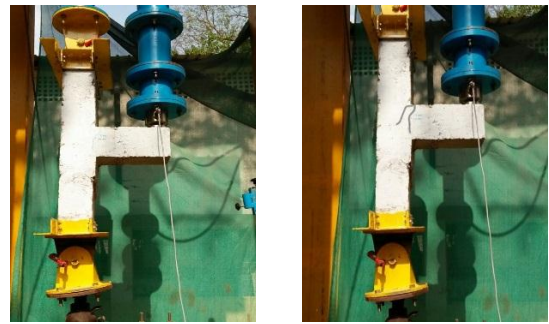
Figure 8: Control specimen before and after testing

After the process of rehabilitation using fibrous concrete, and curing the specimens for the required time, the specimens have been tested under the same test setup as before. The first crack was observed at a load of 17 kN for the deflection of 26.32mm. the ultimate load was 25kN for a displacement of 32 mm(Figure:8)

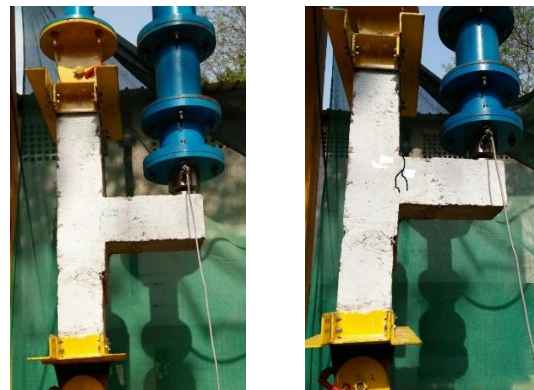
Figure 9: Ductile Specimen Before and After Testing

After the process of rehabilitation using fibrous concrete, and curing the specimens for the required period, the specimens have been tested under the same test setup as before. The first crack was observed at 30.5 kN with a deflection of 17.27 mm and the final crack was observed at 42kN at a deflection of 30.61 mm(Figure:9).

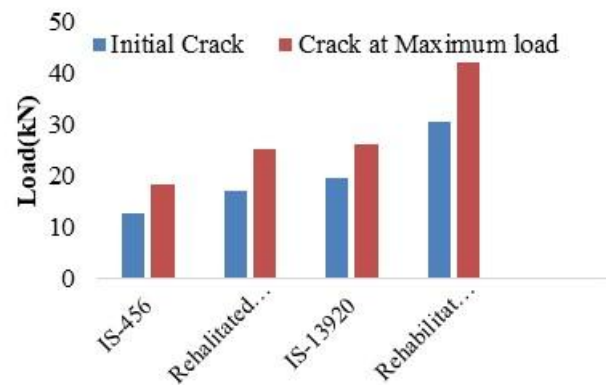
Figure 10: Crack Loads comparison

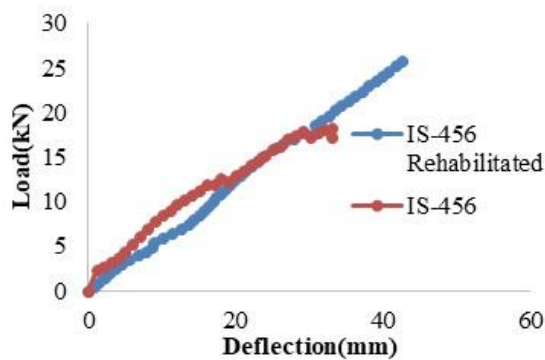
Figure 11: Load Vs Deflection graph of IS-456

The load carrying capacity of rehabilitated specimens were increased 36.6% for IS 456 & 62.3% for IS 13920. The maximum load taken by the conventional IS-456 was 18.3kN at deflection 25mm. The maximum load taken by Rehabilitated IS-456 was 25.8kN at deflection of 42.6mm(Figure:11). The maximum load taken by the conventional IS-13920 was 26kN at deflection 33.04mm. The maximum load taken by Rehabilitated IS-13920 was 21kN at deflection of 9.17mm(Figure:12).

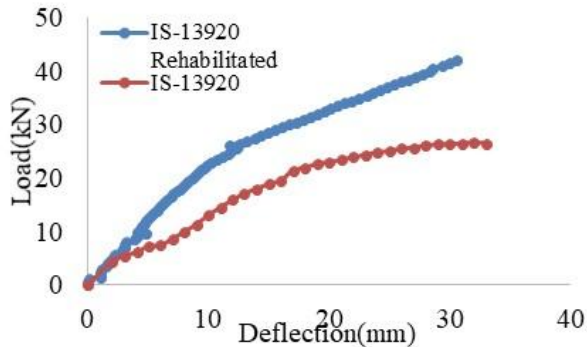
Figure 12: Load Vs Deflection graph of IS-13920
