# Root Cause Detection for Excess Control Rod Vibration in Fuel Injection Pump Using Shainin Methodology

<sup>2</sup>Manufacturing Process, Bosch Ltd, Bangalore, India.

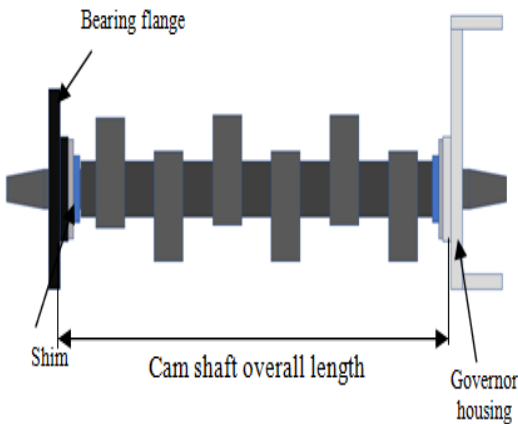
Fig. 10: Cam shaft assembly

On further analysis on cam shaft between good pump and bad pumps, it is found that the overall length of cam shaft is less than length of pump casing for all three bad pumps. The interference between cam shaft assembly and pump casing for good and bad pumps is shown in table

It is observed that interference in bad pump is negative which means overall length of cam shaft is less than pump casing length whereas good pumps follows ideal condition. The reason for this negative interference in bad pumps is further analyzed by finding contrast in various dimensions between good and bad pumps

The shim thickness of all three bad pumps were replaced with required thickness of shim and re-calibrated which is shown in table below.
