Condition Assessment of Fire-Affected RC Slab Via GPR Signal Reflections Analysis and Visual Inspection Method

This study aims to assess the condition of a fire-damaged building for recommendation of repair works. The Institute of Medical Research (IMR) building, in Kuala Lumpur, Malaysia was damaged by fire in April 2011. Visual inspection (VI) is the normal assessment method, but for more accurate results, Ground Penetrating Radar (GPR) signal reflections analysis is employed. The defects analyzed are cracks and delamination of the affected area which was the reinforced concrete (RC) slab at level 3, location where the fire had started. The results obtained using GPR and visual inspection were compared. The area where cracks were detected visually was confirmed by results from the GPR signal reflections analysis but visually, only 28% of the slab area showed delamination defect. When checked with GPR, the area of delamination was actually 56% of the slab area. Cracks and delamination damage mapping was prepared in order to help facilitate repair works. This result shows that Ground Penetrating Radar (GPR) signal reflections analysis had detected delamination in RC slab where nor

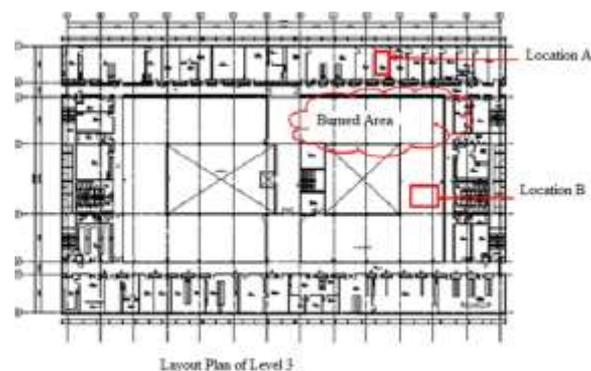
Fig. 2: Location of investigated area

In this study, a fire-damaged building (IMR) has been selected as the damage evaluation case study (Figure 1). The IMR was built in 1974, and in 2011, a massive fire event had occurred and had destroyed partially the building structural elements. The room storing chemicals located at level 3 of the building, where the fire had started was the area with the worst damages (Figure 2). This study focuses on the slab in the room. The damages checked were the cracks and delamination. Figure 2 shows location "A" where the considered slab is suspected to suffer delamination defects while location "B" is suspected to suffer cracks.
