# Effect of Aluminum Powder additive on Erosion and Bending Resistance of Galvanize Layer

Abbas kamil Othman <sup>1\*</sup>

Msc. Metallurgy Engineering,  
Instructor / Missan University

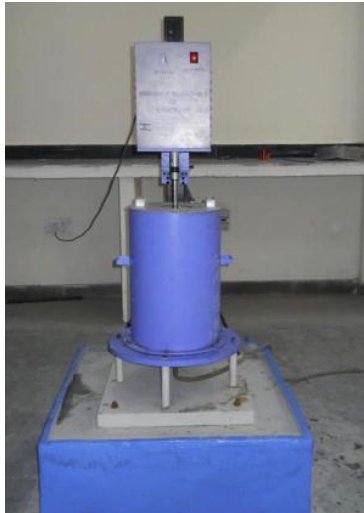
Fig.6: erosion testing

Galvanized samples were prepared at (4.5%, 5%, 5.5% Al) with the dimensions shown in Figure (5) and suitable for installation in the erosion testing apparatus shown in Figure (6). The erosion resistance measured of the galvanize layer was depending to the measurement of hardness (HV). The hardness (HV) of the samples was measured in 15 places in each sample and according to the reading rate to represent the hardness of the sample as shown in Figure (5). Granule sand with a diameter of 2 - 8 mm and a density of 1700 Kg / m<sup>3</sup> was used in the erosion testing

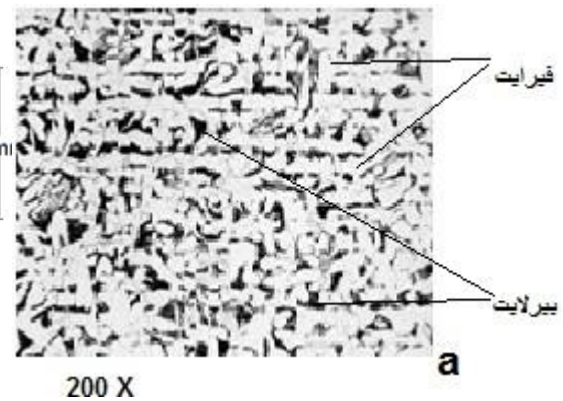
Fig.7.a: shows the microstructure composition of the sample before galvanize process

Figure [7-a] shows the microstructure composition of the sample before galvanize process which consisting of high density Ferrite phase , longitudinal and transverse diffusion ,and perlite phase in the form of longitudinal transverse flakes with different directions. Fig. [7-b] shows the microstructure of the sample after galvanize process which is formed by the ferrite phase as longitudinal strips separated by narrow strips of perlite and this regularity is usually the result of the diffused of some atoms of zinc in the surface of low carbon steel[13].

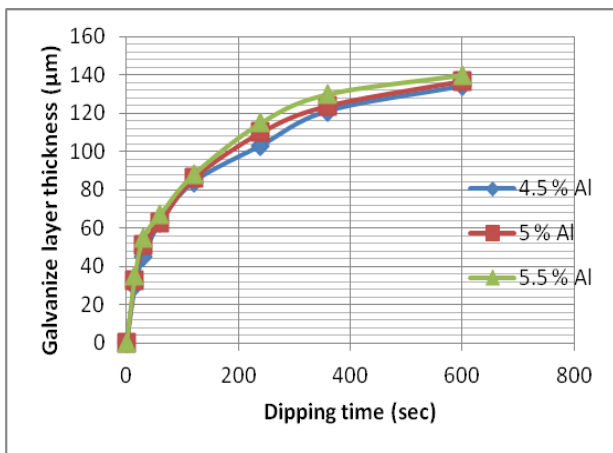
Fig.9: shows the relationship between dipping times in zinc molten and the layer of galvanize

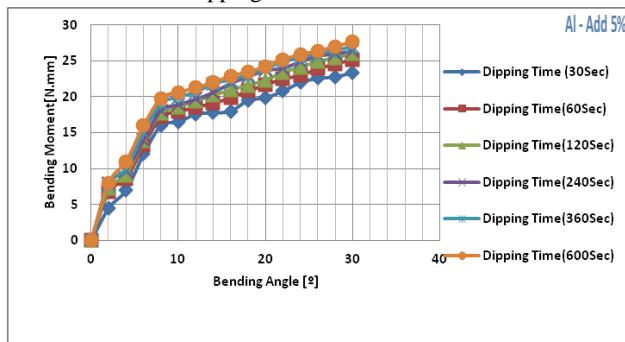
Fig.11: Relationship between bend angle and bending curve (for samples with Al 5% addition)

Figures(11-12) showed similar behavior. However, the increase in the ratio of the addition of the aluminum caused an increase in the bending value when the bending angle was increased by

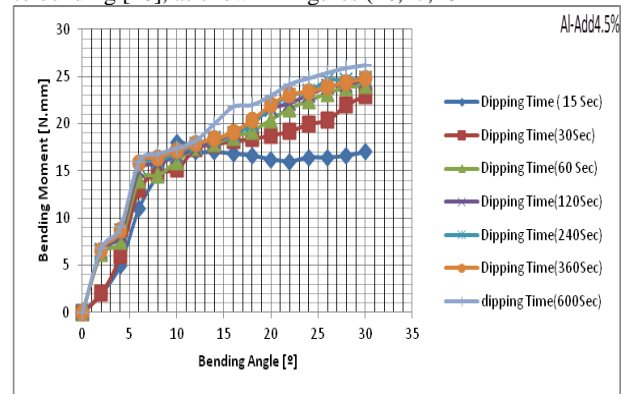
Fig.10: Relationship between bend angle and bending curve (for samples with 4.5% addition)

Figure (12-11-10) shows the relationship between the bending angle and the bending curve produced for (4.5%, 5%, 5.5% Al) and for different time periods of the galvanize. Observed as in figure (10) no effect on the thickness of galvanize layer at period times (15-60 sec.).Effect of the addition was increased when the dipping time was increased and the moment of the bending (bending resistance) increased as the angle of bending,

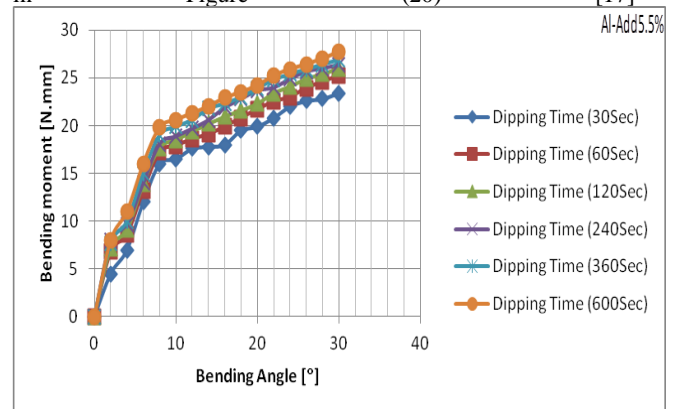
Fig.12: Relationship between bend angle and bending curve (for samples with 5.5% addition rate)

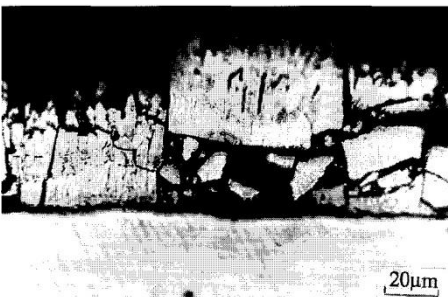
Fig.17: cracks (in the sample (al-5.5%) at the time (600 s)

more than 15 ° due to the increased thickness of the adhesion layer of the steel and the interlayer because the increase lead to increase the galvanize resistance to bending moment [15]. Samples with (Al-5.5% addition) showed the cracking behavior and the nature of the breakage in the galvanize layer with increasing dipping time in the molten as observed in Figs. (13, 14,15,16,17,18) the cracks are formed in the adhesion layer of steel and grow towards the interstellar layer until it reaches the surface layer and whenever the interstellar layer thicker increase the longitudinal cracks in the adhesion and leading to the separation of galvanize layer as showed in Figures (13,14,15), the increase in longitudinal and transverse cracks in the interstellar layer and its growth towards the surface layer leads to a breakage in the total galvanize layer and the breakage of the galvanize layer at the bending angle (30°) were appeared due to the shear stress between the cracks in the thick interstitial layer due to bending [16], as shown in figures (16,17,18

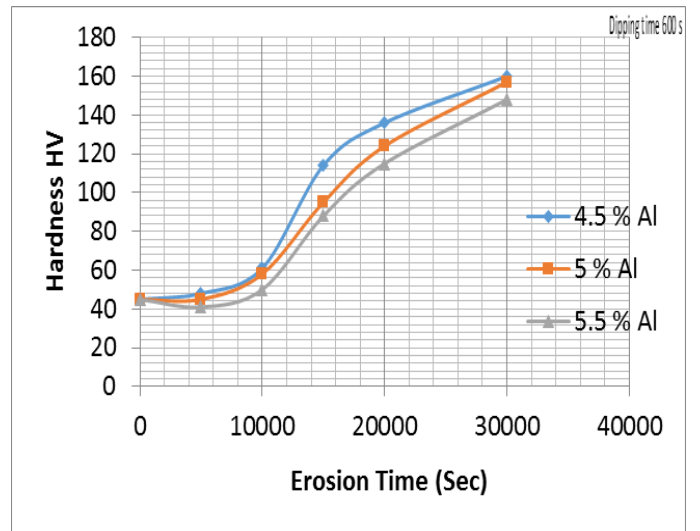
Fig.19: hardness (hv) in samples (al-5.5%, 5%, 4.5%) at dipping time in molten (600s)

Figure (19) shows the relationship between the hardness (HV) and the time of exposure to erosion of the galvanize samples with addition ratios (4.5%, 5%, 5.5% Al). observed that the change few in the hardness of the samples at the time of exposure to the limit of (10000 s) in the presence of Thickness galvanize layer at the beginning of time When more than (10000 s) is passed, the value of hardness is increased due to the removal of the layers of galvanize to reach the highest hardness value, which represents the hardness of the steel. It was noted that the minimum addition (Al-4.5%) is slightly stronger than other samples this is due to the low thickness of the galvanize layer in it. This indicates that erosion resistance is associated with and is strongly affected by the thickness of the total galvanize layer, especially the layer Adjacent to the surface of the steel as shown in Figure (20) [17]
