Preliminary assessment of the pollution status of Sapang Balen river, Mabalacat city, Philippines

Glen S. Nolasco^{1*}, John Dave A. Dicuango², Marilyn S. Arcilla¹, John Edward E. Alfonso³

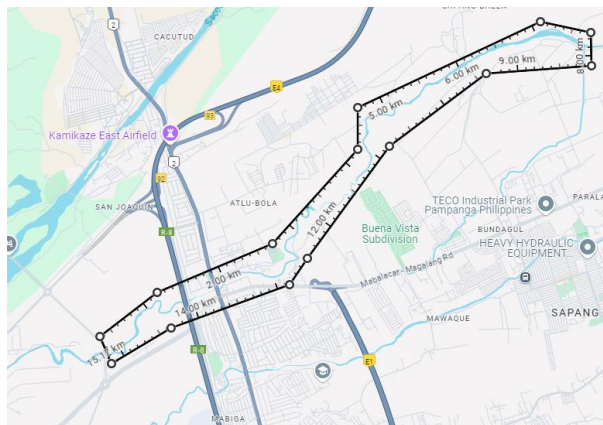
Fig. 1: Map Showing the Covered Area of the Sapang Balen River, Including the Riparian Section.

The location of the study was on the Sapang Balen, Mabalacat City, Pampanga, Philippines. The subareas of the conduction were divided into headstream and middle stream. The coordination of river, 15°14'37"N·120°36'42"E·15.24376,120.61175 was obtained using a GF-07 GPS tracker. The certificate of conduction was issued by City Environment and Natural Resources (CENRO) of the Mabalacat City LGU.

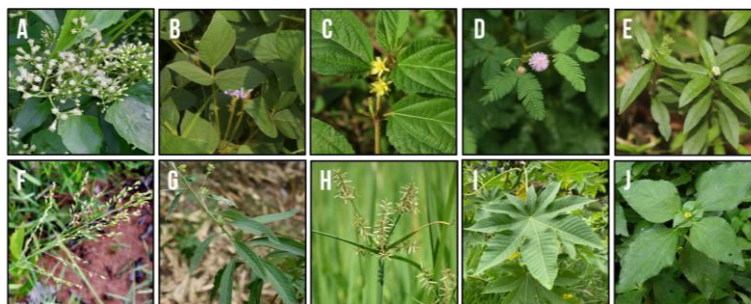
Various species of flora, belonging to different families, have been observed and identified situated on the riverbanks of Sapang Balen (Figure 2). The identified plants in the riparian system of Sapang Balen have both positive and negative impacts on its freshwater ecosystem. Certain species, such as *M. cordata*, *C. capsularis*, *E. prostrata*, can provide control to soil erosion through roots, fibers (Raman et al. 2018), and symbiotic relationship (Duc et al. 2021). Other plants, such as *C. mucunoides* and *M. pudica*, contribute to nitrogen fixation that can improve soil fertility (Ferreira et al. 2016). However, most of the plants are fast-growing often leading to competition for space and resources. Some are also known to release allelochemicals (*M. cordata*) (Hossain et al. 2016) and toxic compounds (*R. communis*) (Landoni et al. 2023) that can alter the ecosystem balance. It can also be noted that the plants are classified as weeds, mainly from disturbed areas of Sapang Balen, showing low biodiversity of the riparian area. Riparian areas invaded by weeds indicate a threat to ecosystem health. A healthy riparian system is crucial to maintaining the health of freshwater system and therefore effective weed management must be implemented (Sheley et al. 1995).

Fig. 2: Identified Plants in Sapang Balen. A. *Mikania Cordata*. B. *Calopogonium Mucunoides*. C. *Corchorus Capsularis*. D. *Mimosa Pudica*. E. *Eclipta Prostrata*. F. *Panicum Sp.* G. *Blumea Sp.* H. *Cyperus Rotundus*. I. *Ricinus Communis*. J. *Synedrella Nodiflora*

The ecological assessment of Sapang Balen's riparian system highlights both the beneficial and detrimental effects of its flora on the ecosystem. Species like *M. cordata* and *C. capsularis* aid in soil erosion control, while *C. mucunoides* and *M. pudica* enhance soil fertility. However, the rapid growth of certain plants and the release of allelochemicals pose threats to biodiversity, with the presence of weeds indicating ecosystem disturbance. These findings, however, require follow-up and confirmatory tests.
